An Experimental Investigation on the Causes of Flexible Pavement Failures: A Case Study on Tarcha - Yalo Road Section

Hailemichael Debalke Damota, Abel Tesfaye, Anteneh Geremew. (2023). An Experimental Investigation on the Causes of Flexible Pavement Failures: A Case Study on Tarcha - Yalo Road Section. *American Journal of Civil Engineering*, 11(4), 44-53.

Keywords: Pavement Distress, Distress Type, Laboratory Tests, ERA 2013, Condition Survey

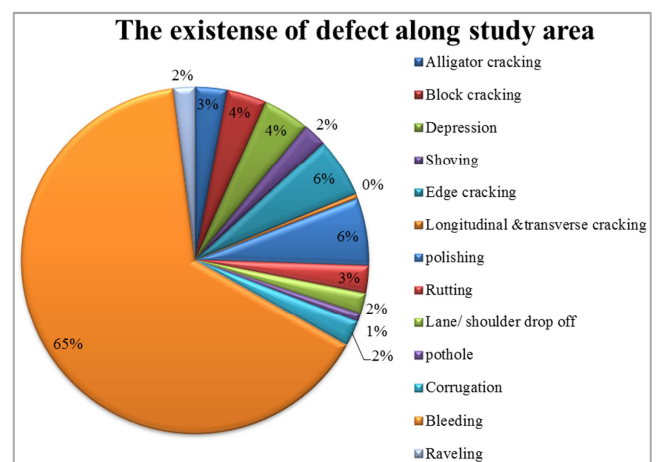
Figure 3. Pavement distresses distribution percentage.

The condition survey of the selected road segment was subdivided into five sections of road segments. The sections of segments Tarcha-Turi (19%), Waka-Tulema (24%), Tulema-Gesa (19%), Gesa-Ellabacho (16%) and Ellabacho-Yalo (22%). The survey was carried along the five subdivided sections and different types of flexible pavement distresses were viewed and observed. Distresses observed along the sections were alligator cracking, block cracking, depression, shoving, corrugation, polishing, edge cracking, edge drop off, rutting, raveling, transverse and longitudinal cracking, potholes and bleeding. Among the observed distresses Alligator cracking, potholes, bleeding, edge cracking, rutting and raveling were majorly dominant whereas depression, block cracking, shoving and polishing were moderately dominant and transvers and longitudinal cracking, edge drop off and corrugation were the least dominant.

According the findings of the results from pavement distresses the dominant failures were structural and material failures. The structural failures were subjected to traffic load because the thickness of the pavement structures obtained in the field are not enough to withstand the traffic loads and the material factors were subjected to constructions condition and laboratory result influences because the compaction and material quality of sub grade and base course in failed section are not satisfied the ERA and AASHTO specifications. The construction was in progress of construction and the distresses were premature which implies the structural and environmental related problems should be the best concern and are the causes for failures.

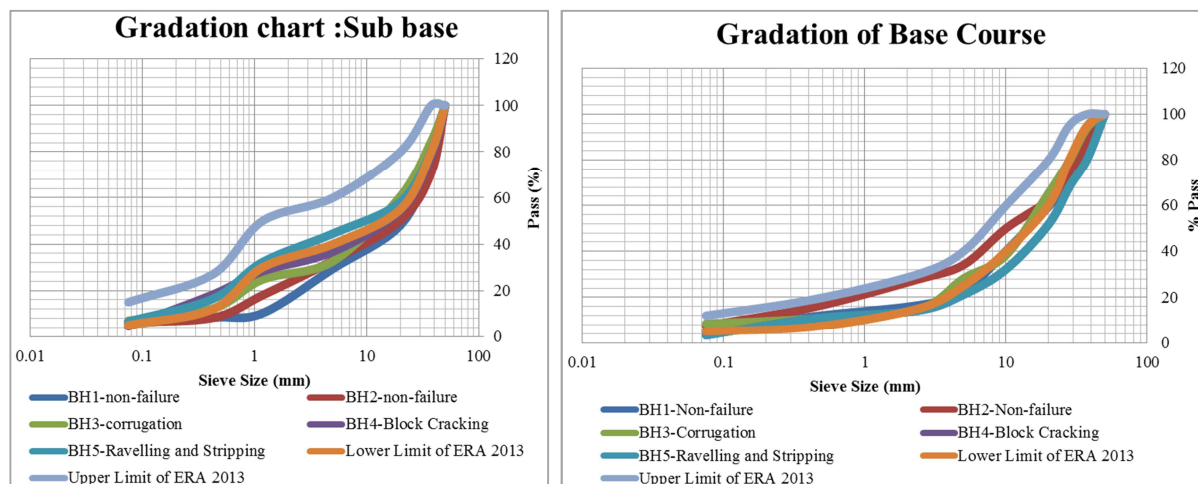
Figure 4. Gradation curve of Sub Grade, Sub Base and Base Course.

Comparing the laboratory test results for gradation with that of the specification for Base, and sub base materials and to determine the percentage of gravel and sand from grain size curve depending on percentage of fines (fraction smaller than 75micron sieve size) coarse grained soils are classified as follows: less than 5%: GW, GP, SW and SP. And more than 12%: GM, GC, SM, and SC. 5%-12% border line case required use of dual symbols. According to Unified soil classification system:-

- 1) In case of base course materials $C_u = 55.1$, which is greater than 4 shows a wide variation of size particles. $C_c = 5.60$, indicates well graded sand particles, According to USCS, base material is classified as well graded sand with gravel.
- 2) For the sub-base materials $C_u = 50.78$, which is greater than 4 shows a wide variation of size particles, $C_c = 2.04$, indicates well graded gravel particles. According to USCS, the sub base material is well graded gravel with sand.
- 3) The subgrade materials are classified as A-2-7, A-4 and A-5 according to AASHTO soil classification system.

Based on to Ethiopian road authority manual 2013, pavement design manual conventional aggregate was classified as graded crushed stone (GB1) and the grading limit of this material for 37.5mm nominal maximum aggregate size was used. As it was observed from the result Figure 3 above, RAPA contains a higher courser than that of a crushed natural aggregate compared to GB1 base course material standard depending on the milling and stockpiling operation. The result recorded above also above shows the ceramic waste aggregates fall within the limit. Generally, the Table 2 and Figure 3 reveal that the gradation results of CSA, RAPA and CWA were between upper and lower limits and

recommended to use as GB1 according to ERA specification. So, the gradation was accepted and suitable for the pavement construction materials.
