Characteristics and Causes of Water Seepage on Riverside Tunnel Structure and Control Measures in Sandy Pebble Stratus

Figure 1. Seepage Photo in site.

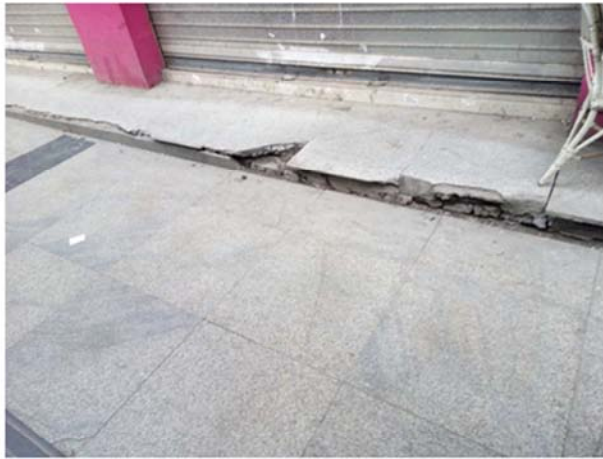
The whole underground tunnel seepage phenomenon is serious, large-scale water and sand gushing mainly concentrated in the original structure deformation joints and construction joints, underground passage water and sand accumulation phenomenon is serious, field investigation found a total of 1828 seepage points. At the same time, the continuous scouring of water takes away the sediment in the surrounding soil of underground engineering, destroys the original structure of surrounding roads and buildings, and even causes surface settlement and deformation. Voids have appeared in many areas. Field deformation diseases are shown in Figure 1.

(a) Surface subsidence and crack

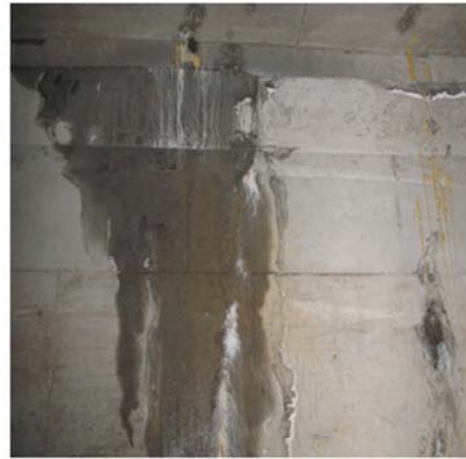
(b) Seepage of sidewall

Most of the point-like seepage points in the side wall are water seepage, which is only reflected in the wetness of the wall. Although most of the linear seepage points of the side wall also show water seepage, the amount of water seepage is very small, which only makes the wall wet (not affected by rainfall); the water seepage and sand gushing of the side wall mainly occur in some wall cracks (i.e. linear seepage points), with a total seepage flow of 176 ml/s.

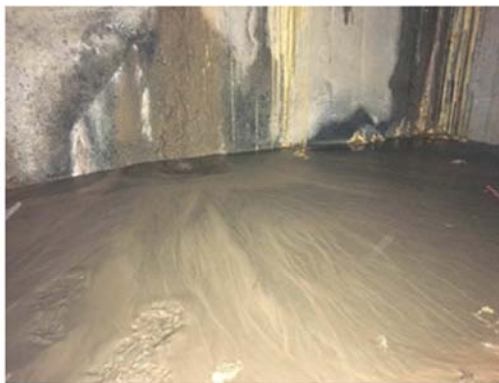
(c) Sand gushing from floor

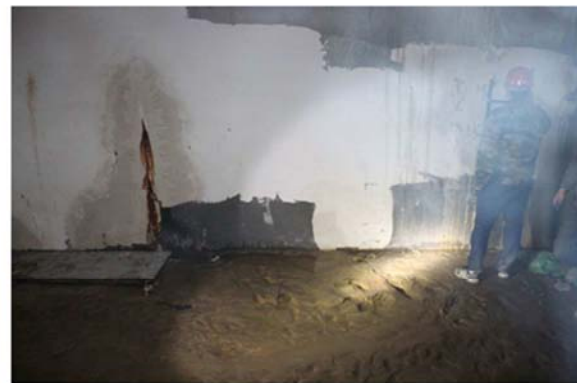
(d) Structural decoration layer seriously damaged

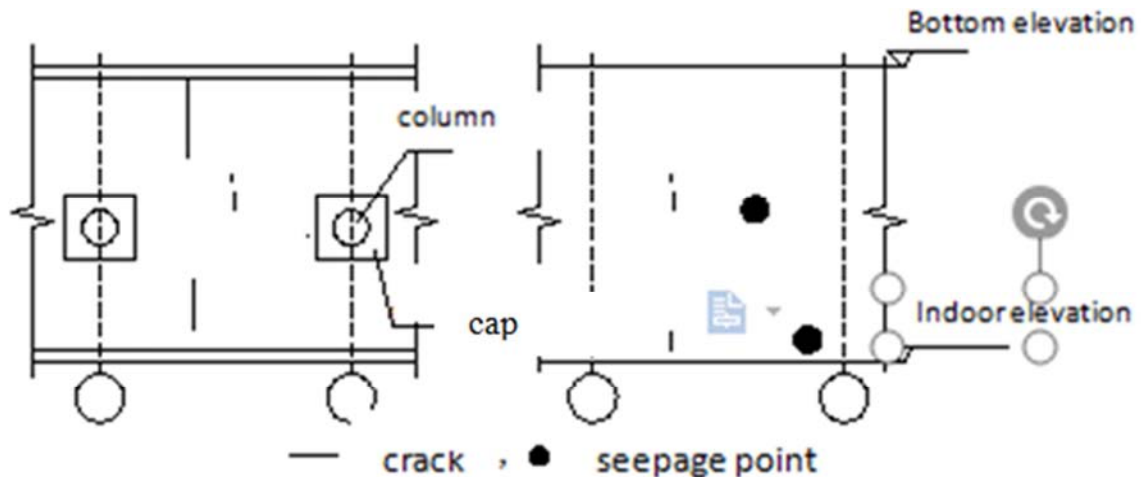
According to the field investigation, the crack development of concrete wall and roof conforms to certain rules. The wall surface is a point-like seepage point, vertical and horizontal seepage zone; the plate surface is mainly a band-like seepage

crack, which is characterized by developing along the transverse axis, long length and terminating at the column cap (or column bracket) or corner, reflecting the significant characteristics of longitudinal tensile stress; a few cracks are developed along the longitudinal axis and have a shorter length, and the roof and wall surface are classical. Figure 2 shows the distribution of cracks.

Figure 2. Diagram of typical crack distribution in concrete roof and wall.

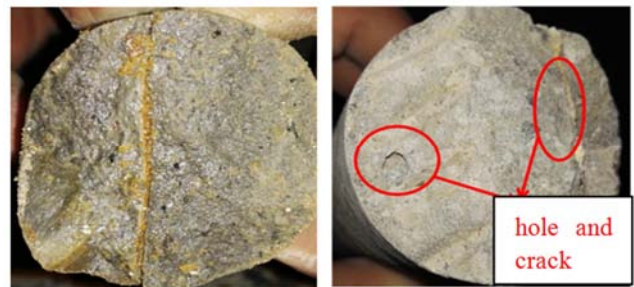
At the same time, according to the data, the waterproofing measures of the project are imperfect, and the inspection results of drilling holes in the side wall show that there are many structural joints and honeycomb holes in the structure. These structural weaknesses are the positions where groundwater is easy to pass through. The weak links provide a channel for groundwater seepage, as shown in Figure 3.

Figure 3. Concrete cracks and holes revealed by sidewall borehole.

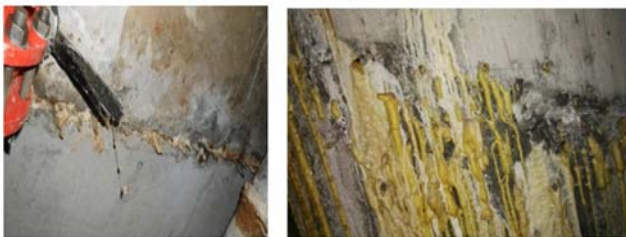
Figure 4. Roof and sidewall grouting.

According to the field investigation, grouting is mainly used to stop water in the early stage of emergency. The leakage points (including deformation joints) are grouted first, and then flexibly protected by polymer sealing materials, which are mainly used for roof and side walls, as shown in figures 4 and 5. According to the engineering geological conditions and the actual situation of structural seepage, the practical application effects of various grouting materials are compared. In the early stage of grouting, grouting materials including single-liquid foaming water-stop agent, polyurethane water-stop agent and rapid water-stop agent are mainly used. After their interaction with water, the grouting materials can rapidly expand and plug the cracks to achieve the purpose of water-stop.

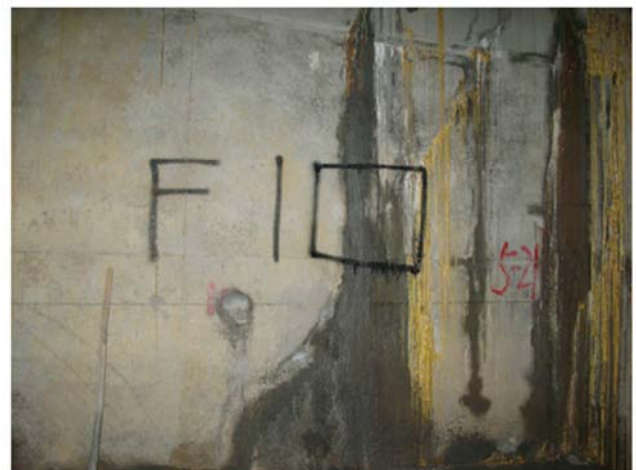
Later grouting treatment is mainly aimed at seepage or serious sand gushing. Side wall water gushing is columnar with a diameter of about 3 cm. At the same time, the water quality is turbid and contains silt. This treatment method has successfully stopped water and blocked sand gushing without

recurrence. As shown in Figure 5, it proves that the grouting treatment measures under the hydrogeological conditions of this project are effective.

Figure 6. Effect of sand gushing treatment.
